Date : 06/03/2025  
Project No : 2025C149  
Client Company : Davidson Homes  
Arrival Time : 06/03/2025 12:30  
Onsite Hours : 05:00

ASEC Report ID : 82229  
Name of the Project : Grove at E. Thompson Mill Rd  
Project Location : Buford  
Weather : sunny  
Departure Time : 06/03/2025 17:30  
ASEC Technician Name : Aminullah Azimi

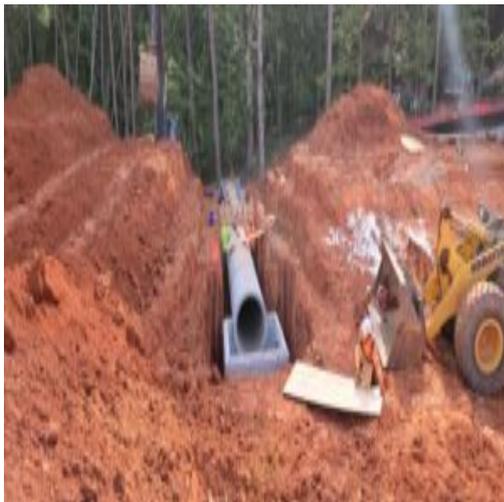
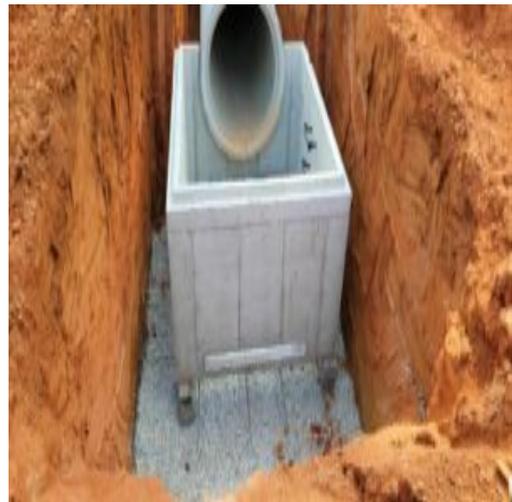
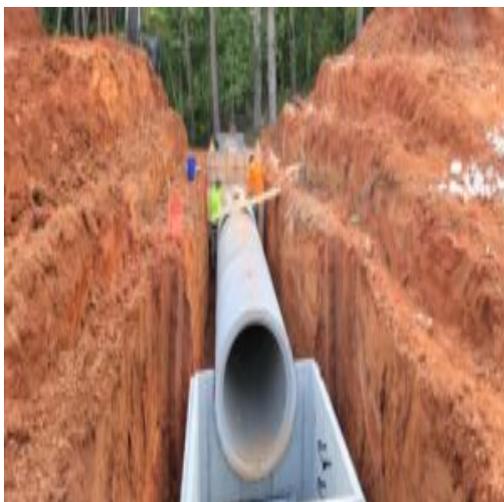
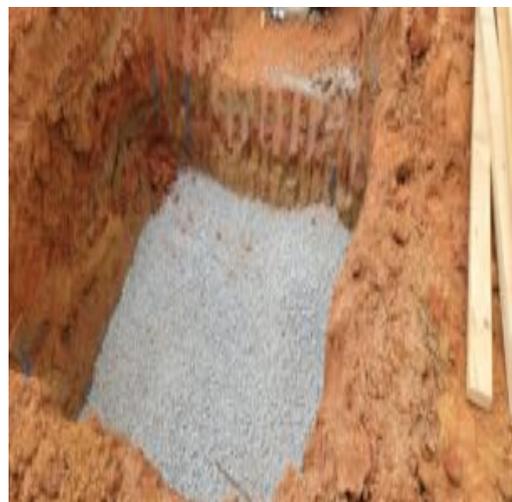
- The placement and compaction of backfill for the outlet control structures in pond-1 and pond 2 continued.
- Upon arrival, our representative observed that pipe placement was in progress, with six-inch lifts being placed and compacted using jumping and trench compaction equipment. Compaction testing was performed along with general probing using a 3/8-inch diameter probe rod.
