Date : 03/27/2025
Project No : 2025C150
Client Company : Davidson Homes
Arrival Time : 03/27/2025 08:00
Onsite Hours : 04:00

ASEC Report ID : 79281
Name of the Project : Riverwood Retaining Wall
Project Location : Dallas
Weather : sunny
Departure Time : 03/27/2025 12:00
ASEC Technician Name : Vamsi Polisetty

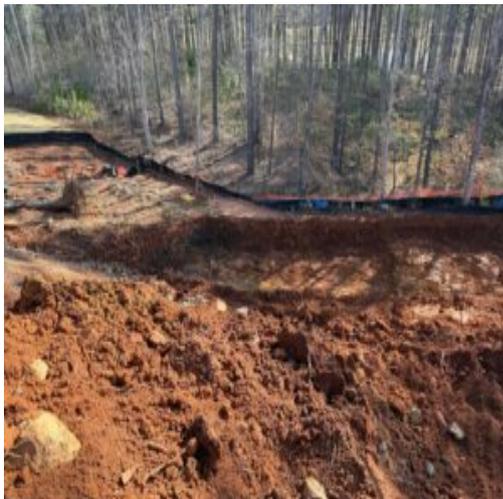
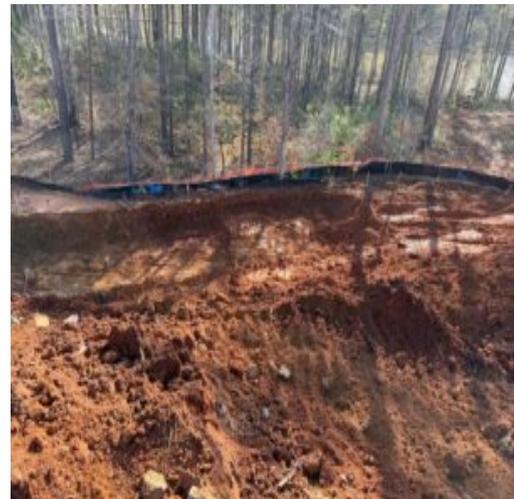
Work has continued behind Lots #225, #226, and #227. The excavation for the retaining wall has been continued, with a cut being made using a Kobelco SK300LC excavator. The contractor has successfully removed soft grey soils down to suitable, stable soils.

The excavated material is being moved using a CAT 725 truck, and compaction is being carried out with a Bomag sheep's foot compactor. Additionally, general probing has been performed to verify the stability of the underlying soils.
