Date : 04/04/2025
Project No : 2025C150
Client Company : Davidson Homes
Arrival Time : 04/04/2025 08:00
Onsite Hours : 08:00

ASEC Report ID : 79596
Name of the Project : Riverwood Retaining Wall
Project Location : Dallas
Weather : sunny
Departure Time : 04/04/2025 16:00
ASEC Technician Name : Vamsi Polisetty

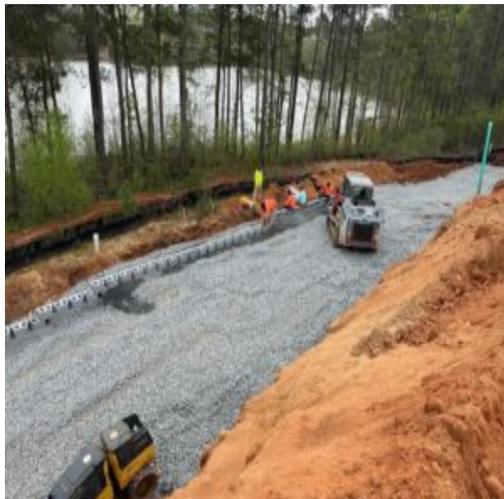
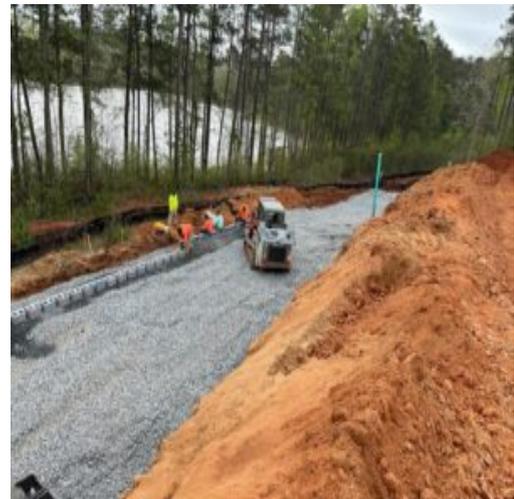
Work has continued behind Lots #225-230. The contractor has made progress in the preparation of the retaining wall foundation.

The construction of the retaining wall has commenced, with the first course of the wall successfully laid using DMDPro Strilface Gray blocks along Lots #225-230. The alignment, setting, and securing of the initial layer have been completed. Beneath the first layer of the retaining wall, a compacted base of No. #57 stone has been placed.
