Date : 04/10/2025
Project No : 2025C160
Client Company : Artisan
Arrival Time : 04/10/2025 11:00
Onsite Hours : 02:00

ASEC Report ID : 79699
Name of the Project : Rockmart Township - 115 Felton Drive
Project Location : Rockmart
Weather : overcast
Departure Time : 04/10/2025 13:00
ASEC Technician Name : Sean Willett

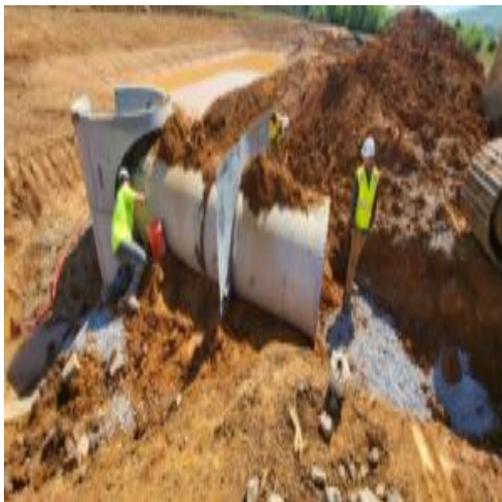
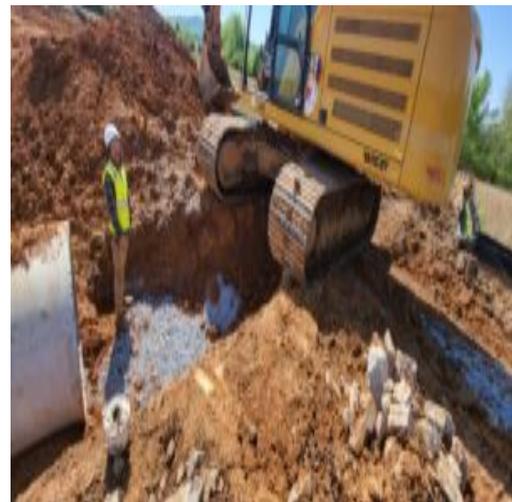
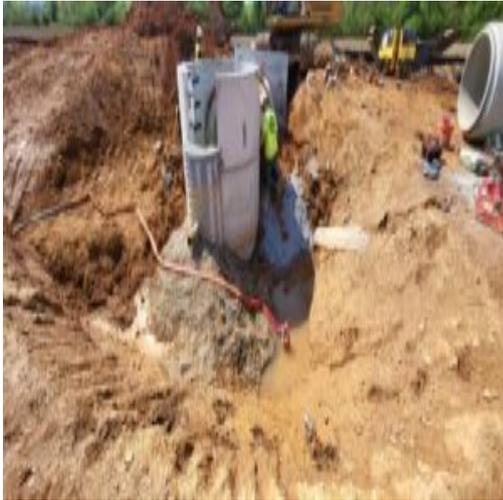
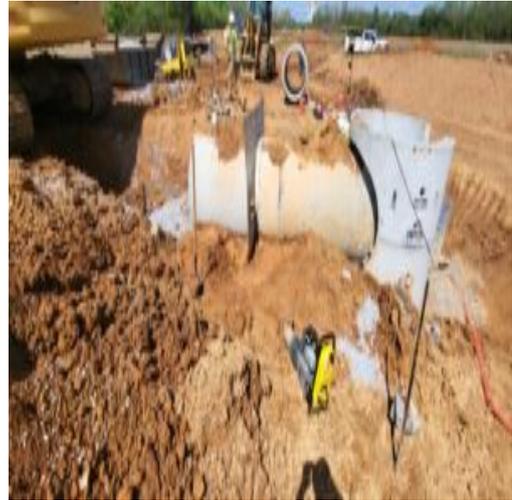
Our ASEC representative was on site as requested by the contractor (Wilbanks) for the observation of the installation of an OCP in the retention pond located by Lots #140 through #143. The OCP outlet pipe was undercut approximately 4 feet due to low compaction/high moisture contents of the backfill. The contractor filled the undercut with approximately 3 to 3.5 feet of riprap and capped the riprap with No. 57 stone for the bedding of the pipe. The contractor is backfilling and compacting the soil around the OCP and compaction testing will then be performed. At this time, no tests were conducted.
