Date : 04/25/2025
Project No : 2025C160
Client Company : Artisan
Arrival Time : 04/25/2025 9:30
Onsite Hours : 06:30

ASEC Report ID : 81687
Name of the Project : Rockmart Township - 115 Felton Drive
Project Location : Rockmart
Weather : cloudy
Departure Time : 04/25/2025 16:00
ASEC Technician Name : Aminullah Azimi

As requested, the site was visited by our AS Engineering and Consulting (ASEC) representative for the purpose of providing quality control inspection and testing services. Visual observation techniques were employed to verify compliance with project drawing/specifications, applicable codes, and materials submittals. The following observations were observed on site this day.

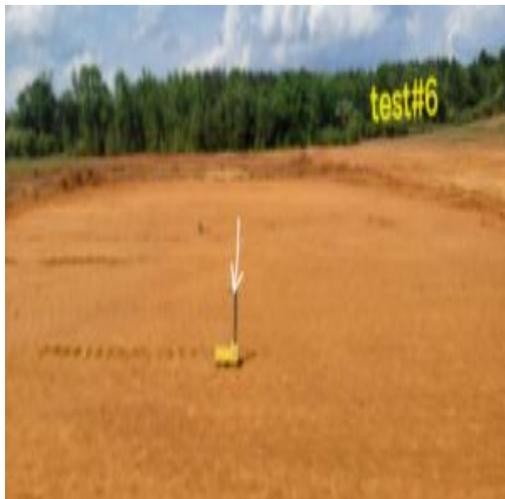
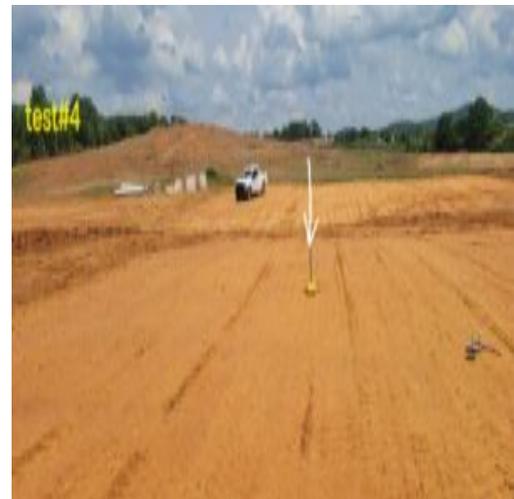
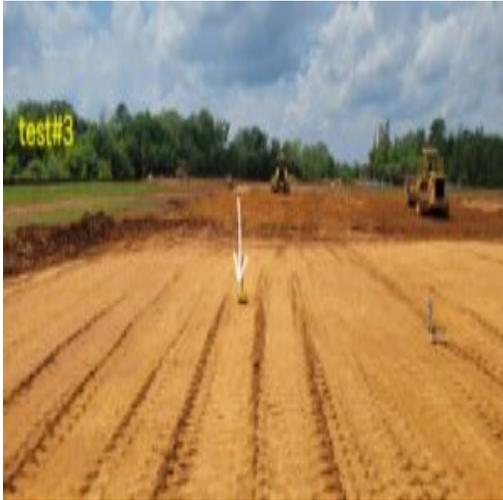
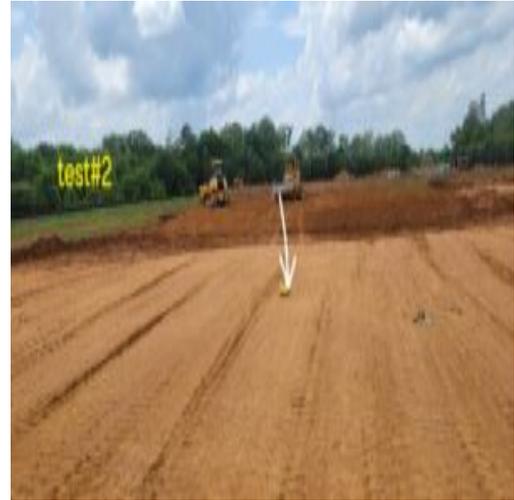
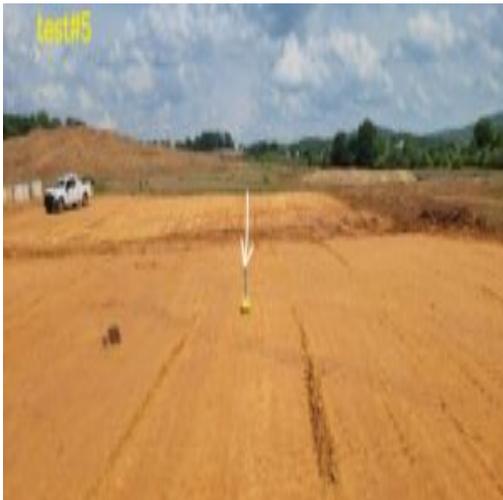
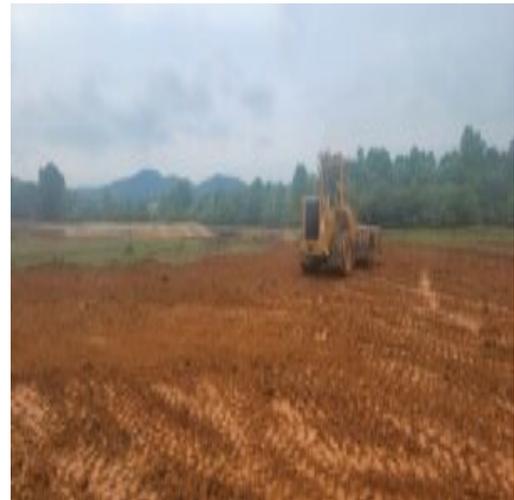
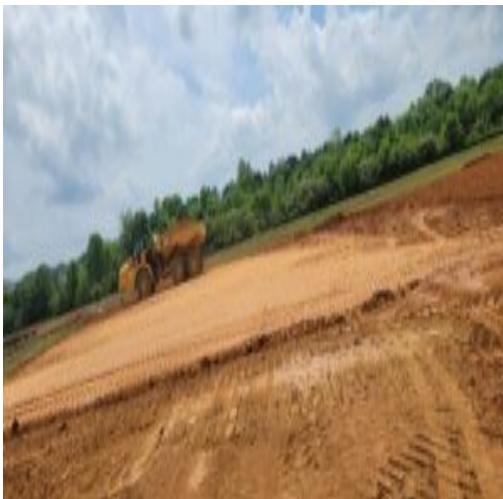
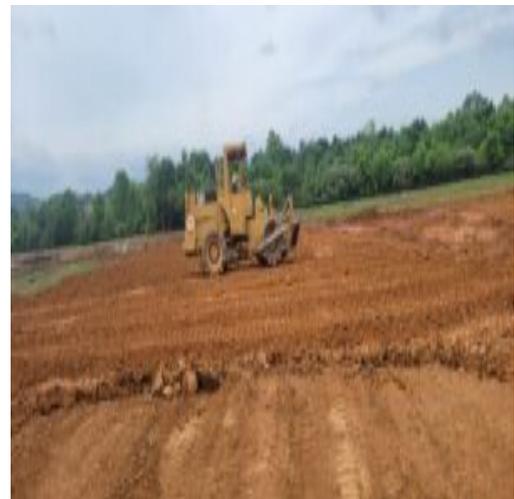
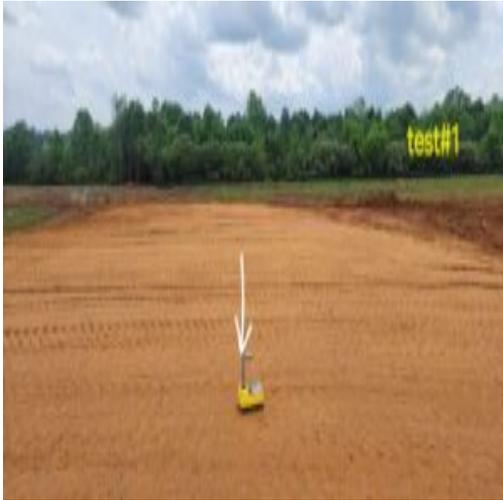
- The placement and compaction of fill for Lots #116, #117, #118, #119, #120, #121 continued today. A soil sample was retrieved and returned to our laboratory to perform a moisture-density relationship (proctor).
- At the time of arrival, our representative observed that work was in progress with 1-foot lifts being placed and compacted using 815 compaction equipment. Compaction testing was performed using a Troxler nuclear density gauge of Soil (ASTM D 2937), along with general probing using a 3/8" diameter probe rod.
- Density test results indicate that the compacted materials met the project requirement of 95% of the maximum dry density obtained by a Standard Proctor ASTM 698.
