Date : 05/22/2025
Project No : 2025C160
Client Company : Artisan
Arrival Time : 05/22/2025 10:00
Onsite Hours : 02:00

ASEC Report ID : 81826
Name of the Project : Rockmart Township - 115 Felton Drive
Project Location : Rockmart
Weather : Sunny
Departure Time : 05/22/2025 12:00
ASEC Technician Name : Sean Willett

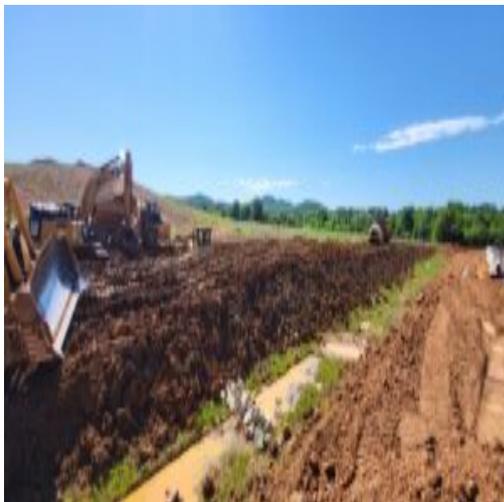
The contractor began stripping topsoil from Lots #134 through #138.

removing topsoil

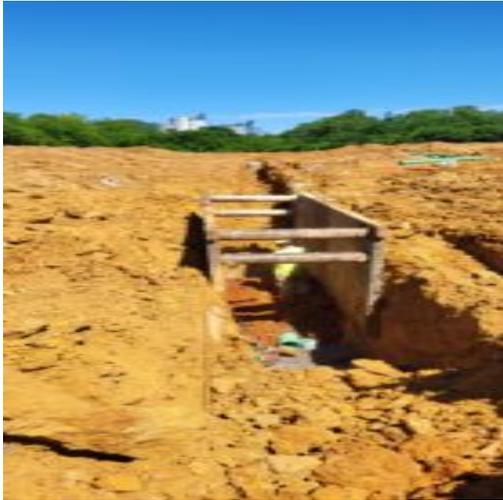
SSMH 4.1 to 4.2

The contractor continued backfilling the pipeline from SSMH4.1 to SSMH4.2. An undercut was approx. 1 foot in depth and bedded with No. 57 stone to elevation.
