Date : 06/23/2025
Project No : 2025C160
Client Company : Artisan
Arrival Time : 06/23/2025 08:00
Onsite Hours : 07:00

ASEC Report ID : 82504
Name of the Project : Rockmart Township - 115 Felton Drive
Project Location : Rockmart
Weather : sunny
Departure Time : 06/23/2025 15:00
ASEC Technician Name : Sean Willett

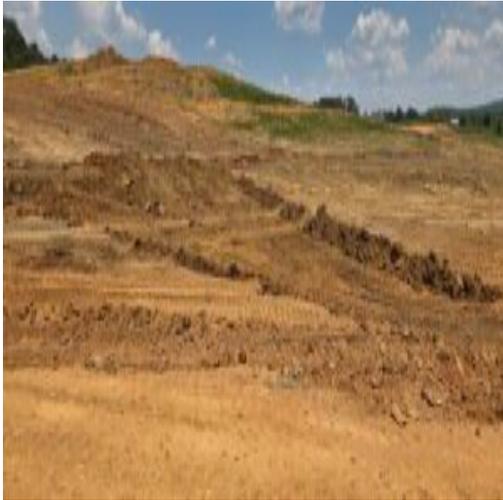
Our representative observed a proof-roll with a loaded offroad dump truck across the approximate location of Lots #140- 136. These lots showed signs of severe pumping and rutting. The technician recommended to excavate this area to remove wet soils and since over 10 feet of fill is required in this area, we recommend a compacted 2-foot bridge lift to start with fill placed in 1 foot lifts to follow.

excavated area of low compaction

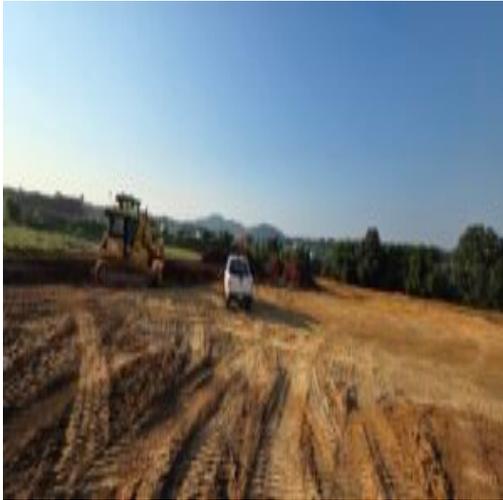
lots 167 - 172

Our ASEC representative was on site as requested by the contractor (Wilbanks) for the observation/testing of the placement of fill/backfill. The technician observed the contractor placing lifts over Lots #167 - 172. Lifts were placed in approximately 8 to 12 inches in thickness. The contractor placed approximately 2 lifts and density testing will be performed in this area on the next available workday.

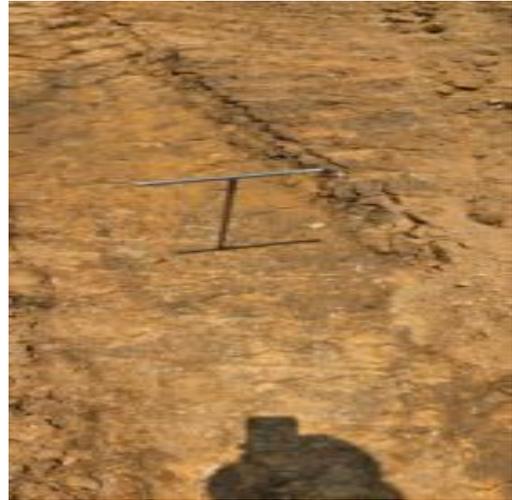
low compaction around lot 140
