Date : 06/24/2025  
Project No : 2025C160  
Client Company : Artisan  
Arrival Time : 06/24/2025 11:00  
Onsite Hours : 01:30

ASEC Report ID : 82525  
Name of the Project : Rockmart Township - 115 Felton Drive  
Project Location : Rockmart  
Weather : Sunny  
Departure Time : 06/24/2025 12:30  
ASEC Technician Name : Sean Willett

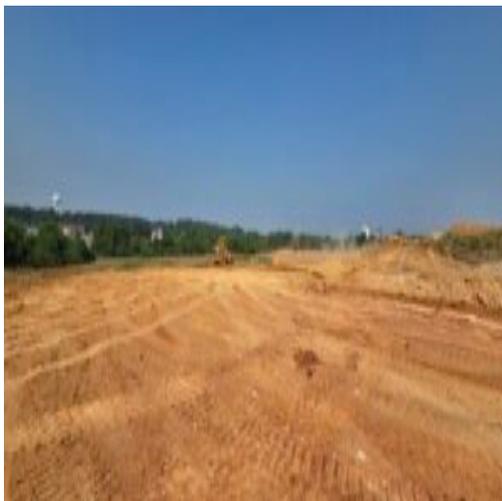
Lots 167 - 172

Our ASEC representative was on site as requested by the contractor (Wilbanks) for the observation/testing of the placement of fill/backfill. The technician observed the contractor place fill for Lots #167 through #172. The lifts were approximately 8 to 12 inches in thickness. The contractor continued placing topsoil along the bank (greenspace) along these lots. The contractor compacts these lots each lift with a non-vibrating sheepsfoot roller. Density testing was performed.

The technician generally probed this area (Lots #167 through #172) which showed stable soils. Approximately every 2 feet, the contractor has been compacting the lifts with a loaded offroad dump truck. There were no major ruts or pumping observed.

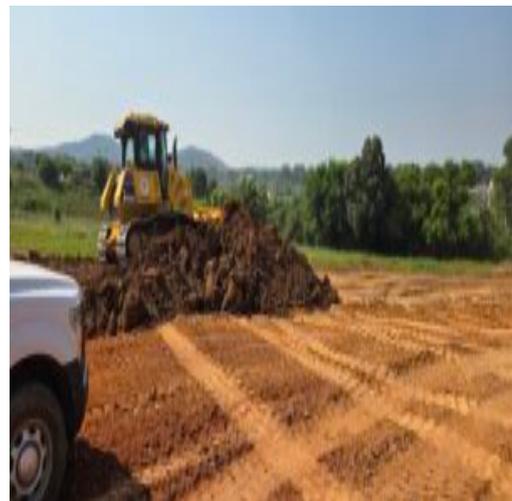
Top soil placement in greenspace
