ASEC Report ID : 82812  
Name of the Project : Rockmart Township - 115 Felton Drive  
Project Location : Rockmart  
Weather : sunny  
Departure Time : 07/03/2025 11:30  
ASEC Technician Name : Aminullah Azimi

Our representative observed a proof-roll and performed density testing on roadway this day.

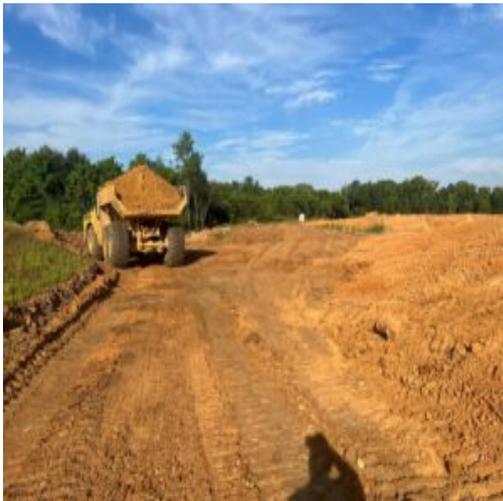
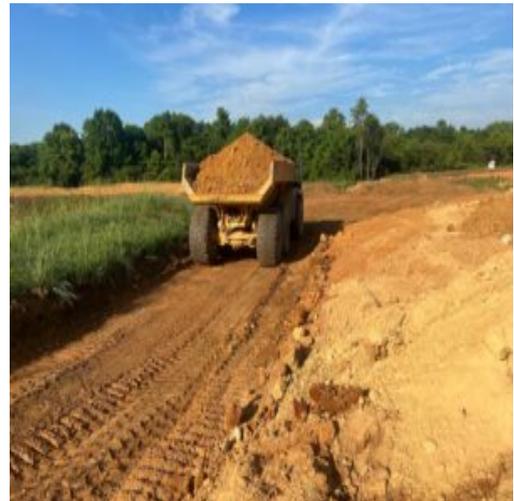
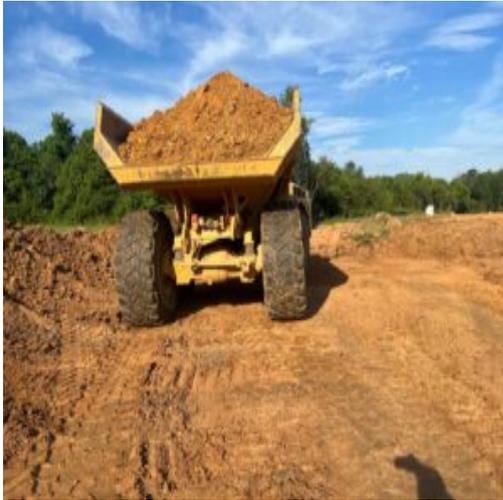
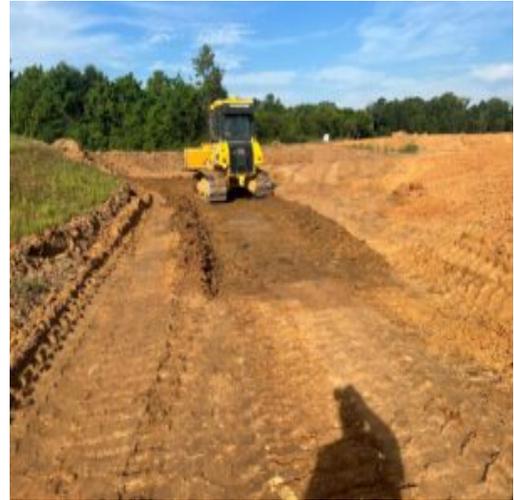
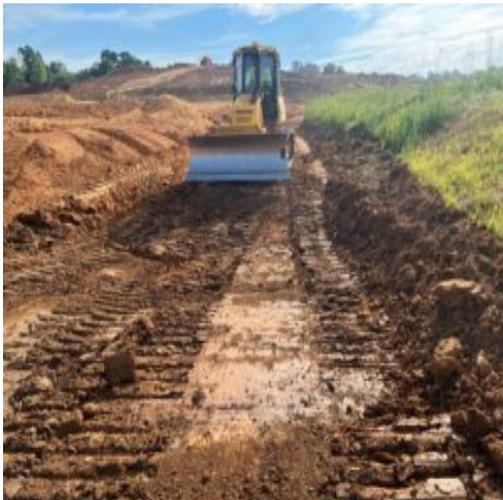
A proof-roll was performed on the roadway before starting fill placement at 6 feet below finished grade in the front of Lot #80 and Lot #81 using a fully loaded tandem-axled dump truck. Multiple passes were made across the area. No significant yielding or deflection was observed during the proof-roll. One small approximate (18'x18') area was recommended to be undercut 2 feet and replace with suitable fill.
