Date : 07/21/2025
Project No : 2025C160
Client Company : Artisan
Arrival Time : 07/21/2025 08:30
Onsite Hours : 05:00

ASEC Report ID : 83243
Name of the Project : Rockmart Township - 115 Felton Drive
Project Location : Rockmart
Weather : sunny
Departure Time : 07/21/2025 13:30
ASEC Technician Name : Sean Willett

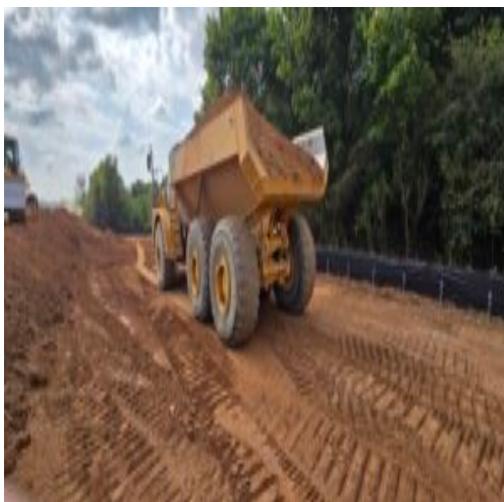
The contractor stripped topsoil from the dog park/pickle ball court area located at main entrance of site (near Lots #88 through #90 area). A proof-roll was performed in this area with a loaded off-road dump truck. The contractor removed a trash pit (old asphalt and curbs) and began to place fill in this area. The trash pit was approximately 145ft x 11ft x 3ft deep. These measurements were provided to the contractor. The lift was placed in approximately 8 to 12 inches in thickness and compacted via a sheep-foot roller and loaded off road trucks.

pickleball / dog park proof roll

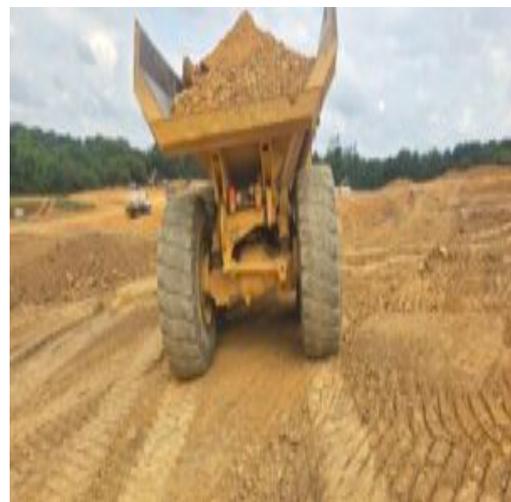
The contractor requested a proof-roll of Lots #173 to the approximate Lot #177 area. Pumping and rutting areas were shown to the contractor for removal. The contractor began placing fill across Lots #173 and #174.

lot 173 proof roll

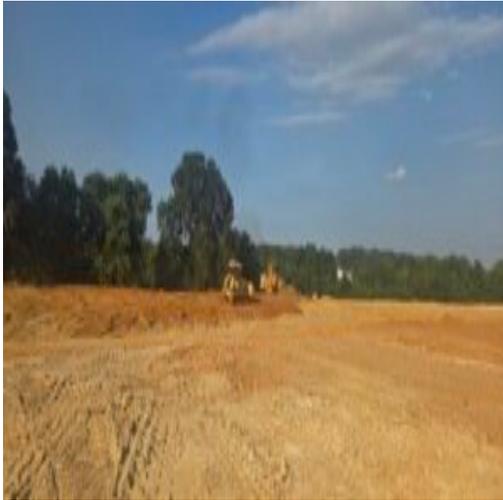
Our ASEC representative was on site as requested by the contractor (Wilbanks) for the observation/testing of the placement of fill/backfill. The technician observed the contractor placed lifts approximately 8 inches in thickness across Lots #72 through #78. Lifts were compacted using a sheep-foot roller. The contractor will roll in the final lift with a loaded truck to seal it off from the rain. The technician will density test the final grade of these lots once this is completed.

lift across lots #72- #78

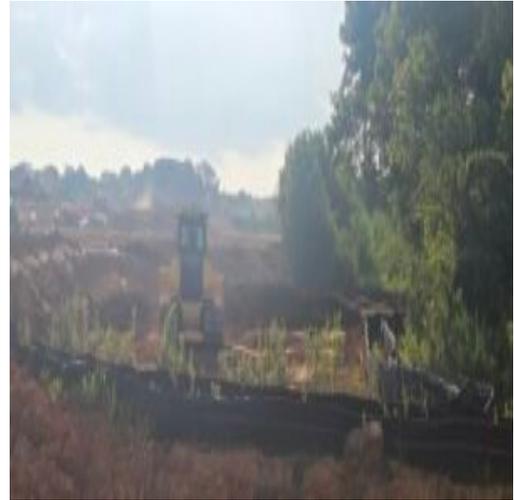
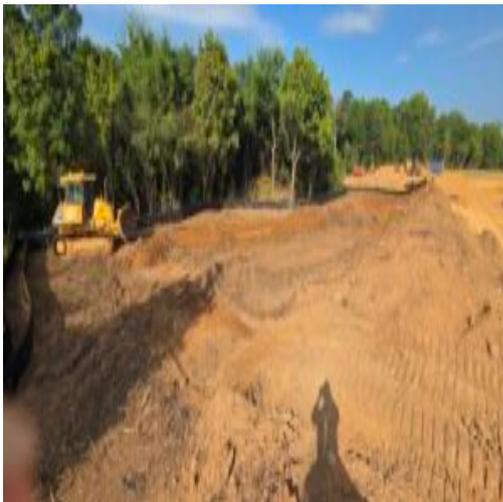
pickleball court / dog park
