ASEC Report ID : 83257
Name of the Project : Rockmart Township - 115 Felton Drive
Project Location : Rockmart
Weather : sunny
Departure Time : 07/22/2025 14:00
ASEC Technician Name : Sean Willett

Our ASEC representative was on site as requested by the contractor (Wilbanks) for the observation/testing of the placement of fill/backfill.

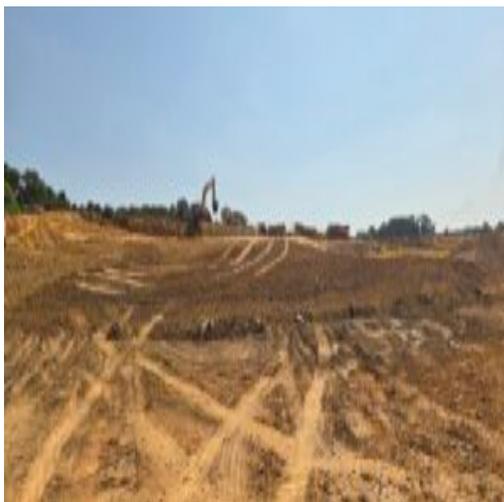
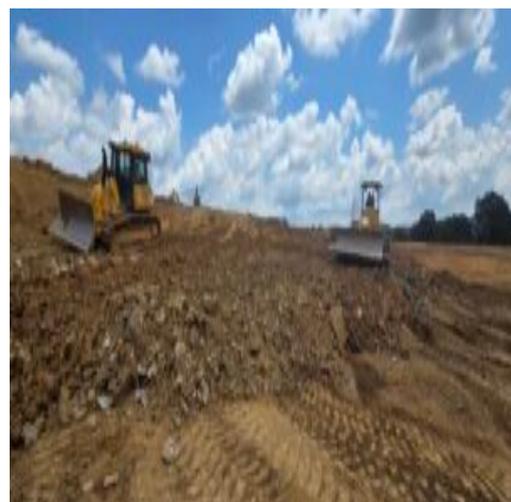
Our representative performed density testing on fill placed on Lots #173 and #174. This area showed high moisture contents. It was recommended to the contractor to proof-roll the lots with a loaded off-road truck to show any signs of pumping or rutting. Pumping was observed so it was recommended to scarify the lot and allow time for the fill to aerate prior to recompaction. The contractor also requested a proof-roll of Lots #175 - #180. A proof-roll was performed and deficient areas were reported to the contractor. The contractor began placing topsoil in green space located in the backyards of these lots.

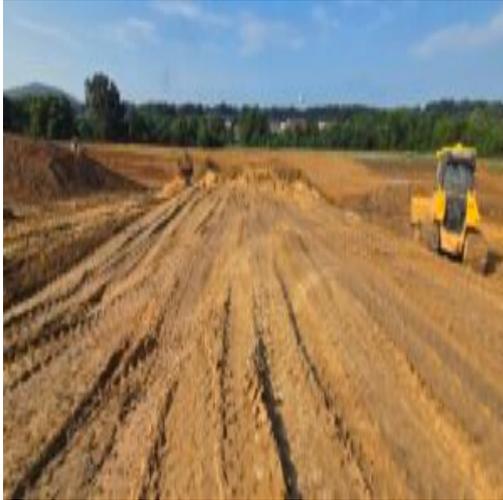
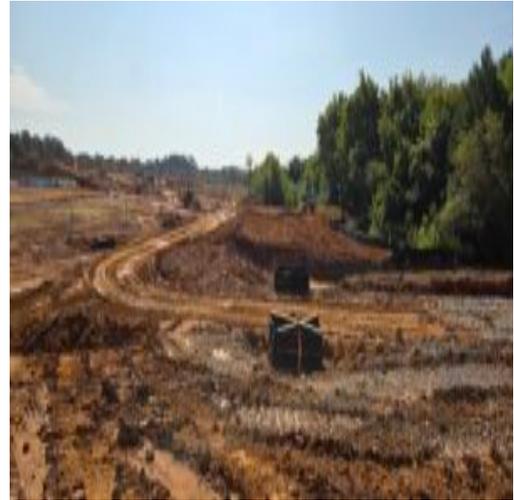
Density testing of the fill placed in the pickle ball court / dog park area by the entrance of the site began. After several recompactions, density tests met the job specifications for compaction.
