Date : 07/30/2025
Project No : 2025C160
Client Company : Artisan
Arrival Time : 07/30/2025 08:30
Onsite Hours : 06:00

ASEC Report ID : 83721
Name of the Project : Rockmart Township - 115 Felton Drive
Project Location : Rockmart
Weather : sunny
Departure Time : 07/30/2025 14:30
ASEC Technician Name : Sean Willett

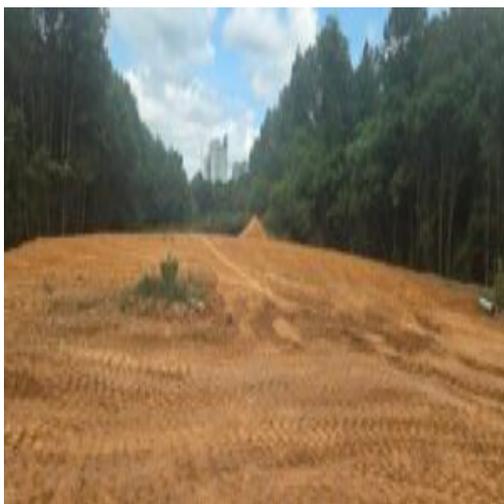
Our ASEC representative was on site as requested by the contractor (Wilbanks) for the observation/testing of the placement of fill/backfill. The contractor began clearing brush and trees from around outside of Lots#15 for the dog park area. The contractor then began placing fill in approximate 8 to 12 inch lifts and compacted via a sheep-foot roller and loaded off road dump trucks. The technician density tested this area. All test results were provided to the contractor.

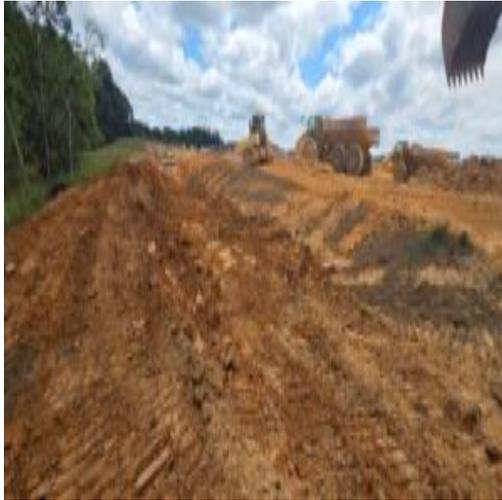
cut from 50 - 52

The contractor requested our representative check Lots #50 through #52 for poor stability. The technician generally probed this area as the contractor cut out wet materials (this area was a temporary detention pond). Once the contractor cut down to 9 to 10 feet of fill, the technician recommended a compacted bridge lift of approximately 2 feet before continuing compaction in one foot lifts. The contractor agreed.
