Date : 03/20/2026
Project No : 2025C211
Client Company : Pulte
Arrival Time : 03/20/2026 07:00
Onsite Hours : 08:30

ASEC Report ID : 91395
Name of the Project : Haley's Bluff - Philadelphia Rd.
Project Location : Jasper
Weather : Sunny
Departure Time : 03/20/2026 15:30
ASEC Technician Name : Sean Willett

Our ASEC representative was on site to observe the contractor (NG Grading) and for the observation/testing of the placement of fill/backfill.

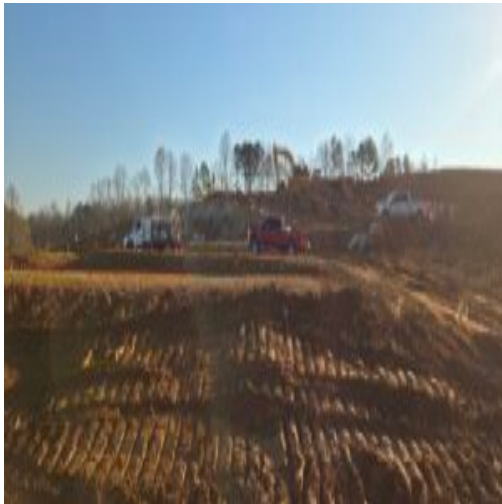
The drillers performed a blast on the previously drilled holes. Both pages of the drill logs are included in the pictures below. When ASEC requested the blasting log, these were the only two sheets provided. Page 1 consists of 41 holes and Page 2 consists of 88 holes drilled in an 8' x 8' grid pattern with a 3.5-inch bit.

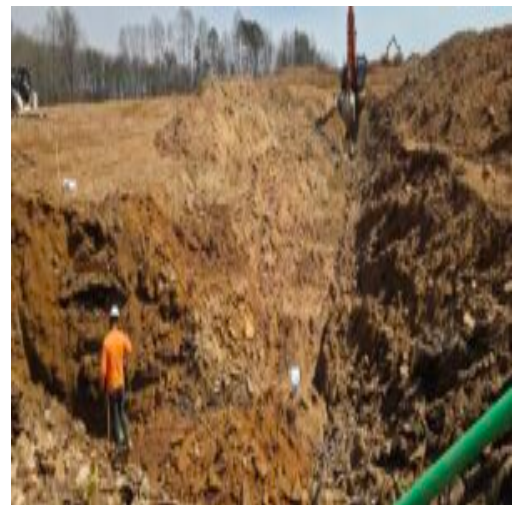
pipe line

The pipe crew began installation of sewer line 3.1 to 3.2. They are installing the clean outs and have not yet begun backfilling the line.

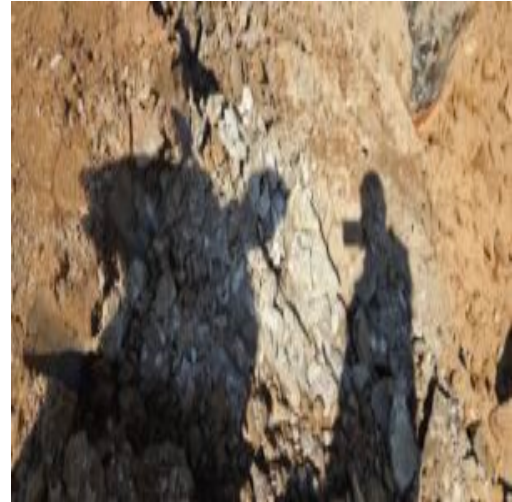
backfill in pipeline area

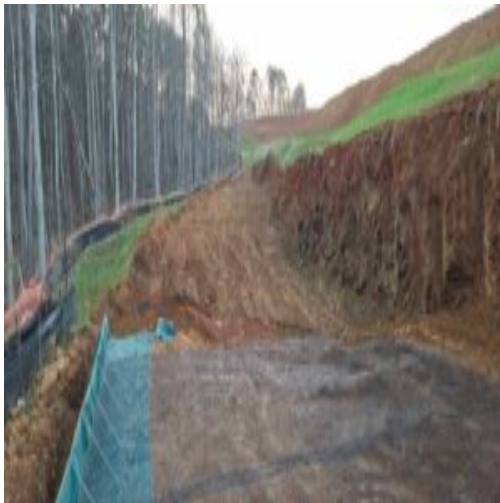
wall1

Late afternoon on the previous workday, the wall contractors said they were ready for testing on the first basket of retaining wall 1. It was explained to them to continue further down the wall and start on the other end of the wall so testing could be performed the next morning. The contractor agreed. Upon arrival to the site, the contractor had instead began building up the next basket over top the 1st basket on the same end of the wall. When asked why they continued installation over top of the first run, they had no explanation. It was explained to them that testing was required on each basket of the wall (as was done on the previous 4 walls) but the contractor continued without proper testing. The wall crew spent the day building up one side of the wall (approximately 5 baskets high) in a section of approximately 50ft to 100ft long. The grading crew and ASEC has asked multiple times why they are not doing full runs across the entire wall. There has been no reasonable explanation. The wall contractors appear to not have the proper equipment to place/compact the lifts. The grading crew is using their dozer and sheep-foot roller to spread the soil and compact.

Lifts for the wall were spread approximately 8 to 12 inches thick and compacted with a vibrating sheep-foot roller. Density testing was performed and test results were provided to the contractor.
