Date : 04/06/2026  
Project No : 2025C214  
Client Company : Artisan  
Arrival Time : 04/06/2026 10:30  
Onsite Hours : 02:00

ASEC Report ID : 92450  
Name of the Project : NW Unit 4 BRIDGE (Materials Testing)  
Project Location : Dallas  
Weather : cloudy  
Departure Time : 04/06/2026 12:30  
ASEC Technician Name : Clyde Smith

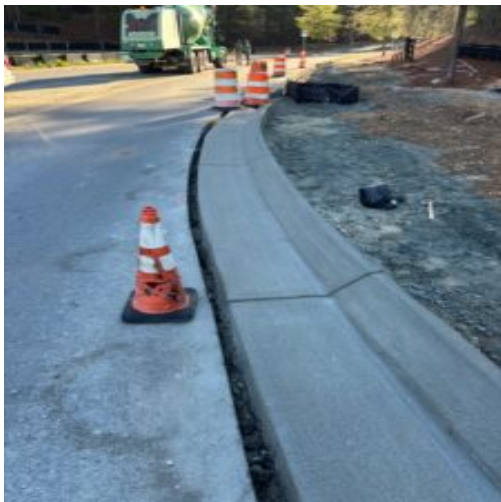
On the above date our representative was on site at the roundabout and bridge foundation observing subbase stone for the east side curbing for the roundabout. The subbase stone was compacted using a vibratory sheep-foot roller and was observed to be suitable for concrete curb placement. The contractor poured type 7 curbing mix today.

Poured curbing at east side round about

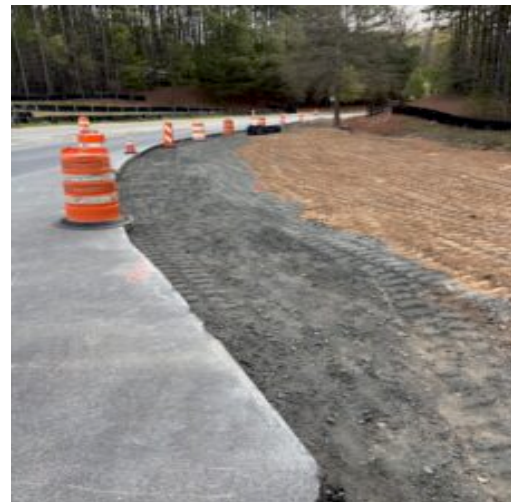
In place sub base stone at east side curbing

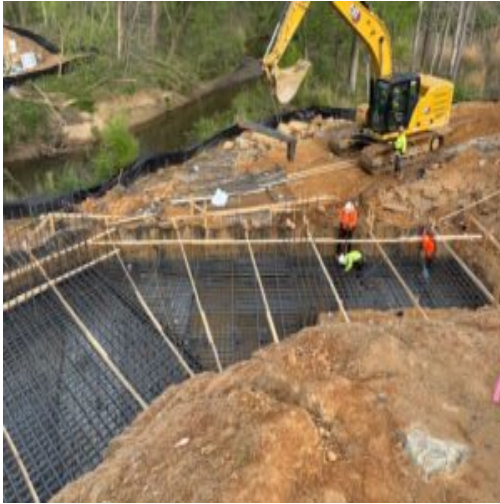
The writer also made several visits observing installation of the reinforcing steel for the north side bridge abutment A1 footing. The areas observed were referenced to the site document in Title Abutment A1, Project: Pumpkinvine Creek Nature Walk Bridge, Project No. 25 RWSO12, dated 4/03/2025, Sheet No. A1 SH-2. Our representative observed the rebar placed for size, spacing, clearance, splice and location. The observations continue as placement is completed.

Reinforcing steel in place at Abutment A1
