Date : 09/04/2025
Project No : 2025C215
Client Company : Artisan
Arrival Time : 09/04/2025 9:30
Onsite Hours : 08:30

ASEC Report ID : 85684
Name of the Project : NW Unit 4 Parkway Ext. Phase 1
Project Location : Dallas
Weather : sunny
Departure Time : 09/04/2025 18:00
ASEC Technician Name : Aminullah Azimi

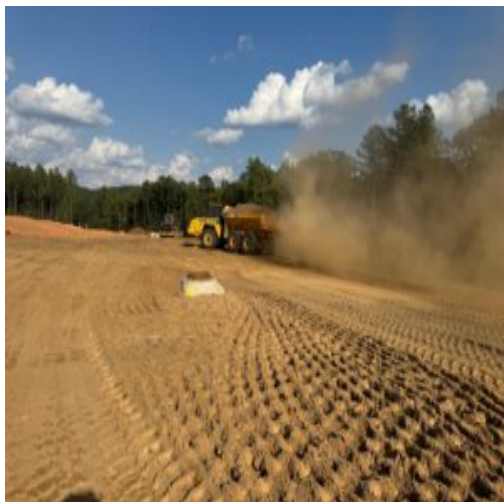
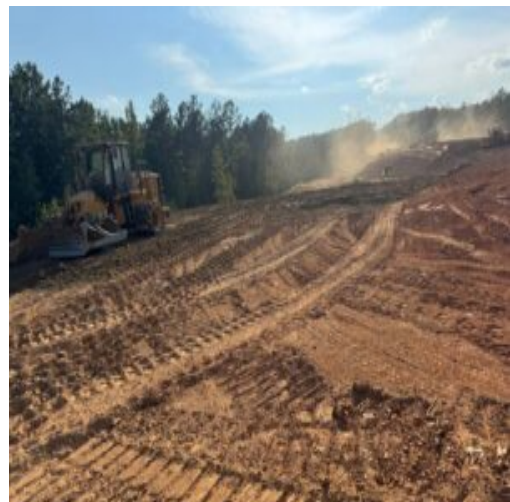
- The placement and compaction of backfill for the sewer trenches between MH6A to MHA3 and MHA4 and Lots #8, 9, 10, 7 and 11 continued on this day. Upon arrival, the ASEC representative observed active work in progress, with backfill being placed in 1-foot lifts. Compaction was carried out using a sheep-foot roller (14-ton) along with a trench compactor for the sewer trench. Compaction testing was performed using a Troxler nuclear density gauge, supplemented by general probing with a 3/8" diameter probe rod. The density test results indicated that most of the compacted materials met the project requirement of achieving at least 95% of the maximum dry density, in accordance with ASTM D698 (Standard Proctor).

NOTE: Performed a 3 Point field proctor as a check.
