Date : 09/03/2025  
Project No : 2025C219  
Client Company : Davidson  
Arrival Time : 09/03/2025 9:00  
Onsite Hours : 07:30

ASEC Report ID : 85646  
Name of the Project : Hickory Bluffs, Retaining Wall  
Project Location : Canton  
Weather : sunny  
Departure Time : 09/03/2025 16:30  
ASEC Technician Name : Aminullah Azimi

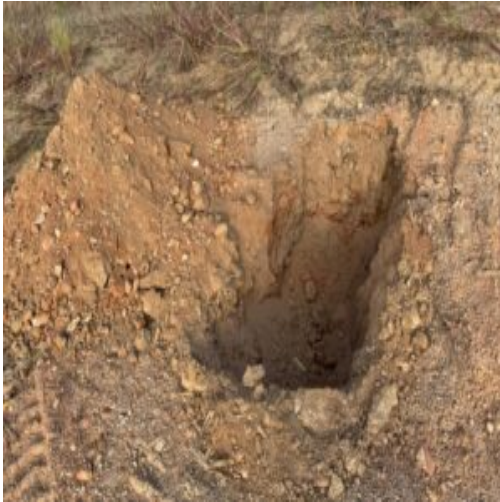
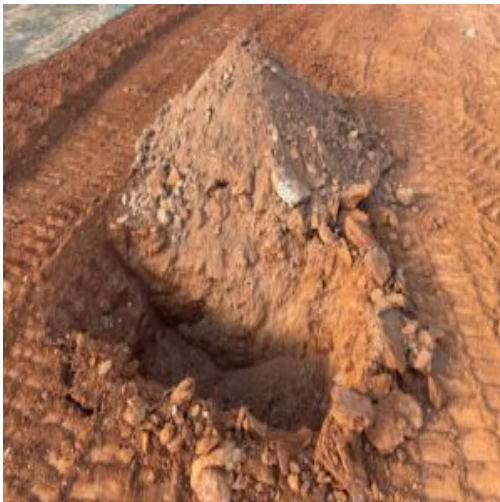
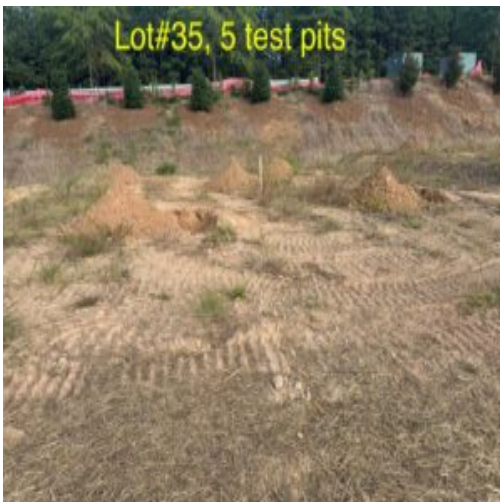
Lot#35, 5 test pits

On this day, test pit investigations were performed by the contractor on Lots #30 through #35 and Lots #62 through #65. For each lot, a total of five test pits were excavated: one at each of the four corners and one in the center. Each pit was excavated to a depth of approximately 24 inches to assess subsurface conditions for potential rock and refusal related to future plumbing and footing installations.

During the inspection, no refusal or obstructions were observed at the excavated depth. While rocks were encountered in several locations, they appeared to be removable during the footing excavation process. These conditions are not expected to pose a significant issue for construction activities.
