Date : 11/17/2025
Project No : 2025C260
Client Company : Artisan
Arrival Time : 11/17/2025 10:00
Onsite Hours : 02:30

ASEC Report ID : 87918
Name of the Project : NW (PHASE 2) Parkway Extension
Project Location : Dallas
Weather : Sunny
Departure Time : 11/17/2025 12:30
ASEC Technician Name : Clyde Smith

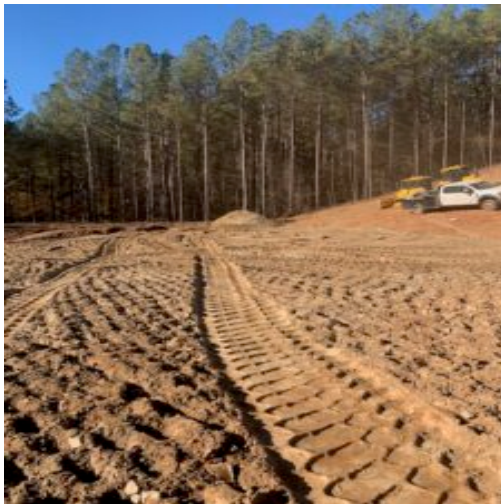
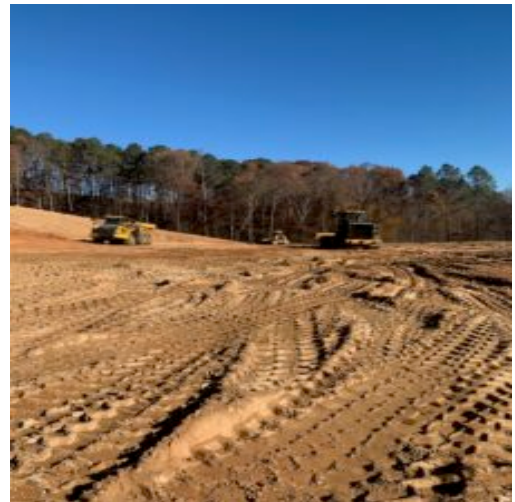
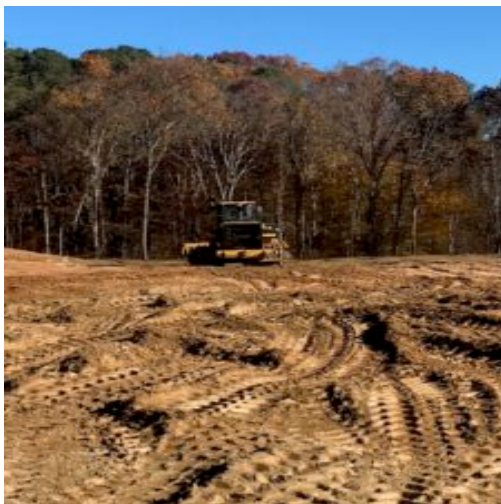
On the above date our representative was on site to observe the grading contractor continue placing rock fill for the slope embankment. The rock fill was placed in accordance with job plans and specifications. The fill placement approved acceptance was at elevations 848, 842 and 830. The fill was placed with a dozer and compacted using a 815 cat sheep-foot roller.

Rock fill placement at slope embankment
