Date : 12/29/2025  
Project No : 2025C260  
Client Company : Artisan  
Arrival Time : 12/29/2025 10:00  
Onsite Hours : 06:00

ASEC Report ID : 88901  
Name of the Project : NW (PHASE 2) Parkway Extension  
Project Location : Dallas  
Weather : cloudy  
Departure Time : 12/29/2025 16:00  
ASEC Technician Name : Clyde Smith

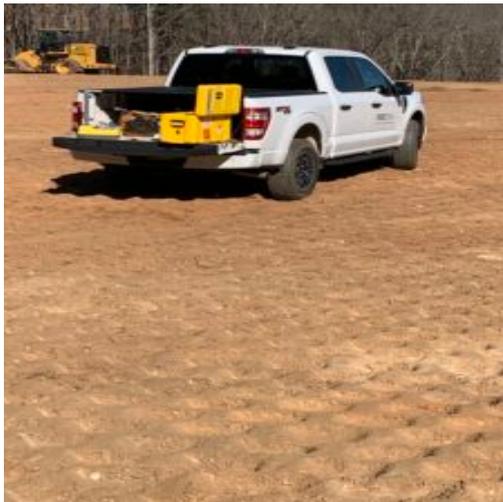
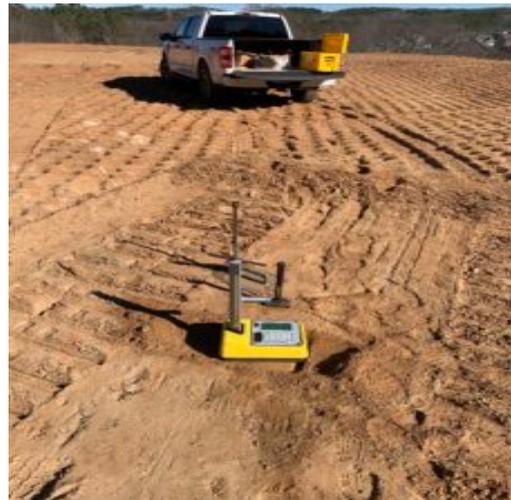
On the above date our representative was on site to observe the grading contractor continue placing fill for the cul de sac basement lots. The writer performed density tests using a Troxler nuclear gauge model 3430, serial no. 91643. Compaction results were in compliance with job specifications and observed at elevations 873, 872, 871, 869 and 870.

Performing density tests at cul de sac basement lots

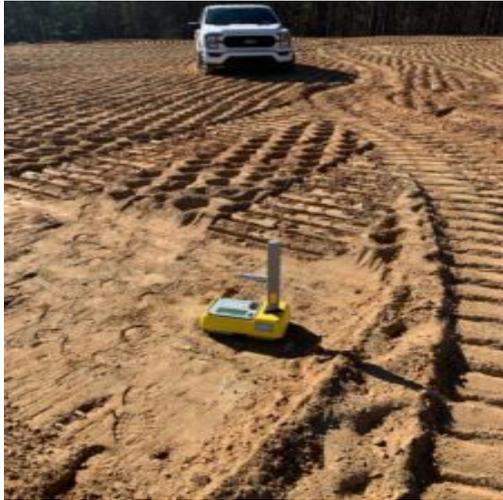
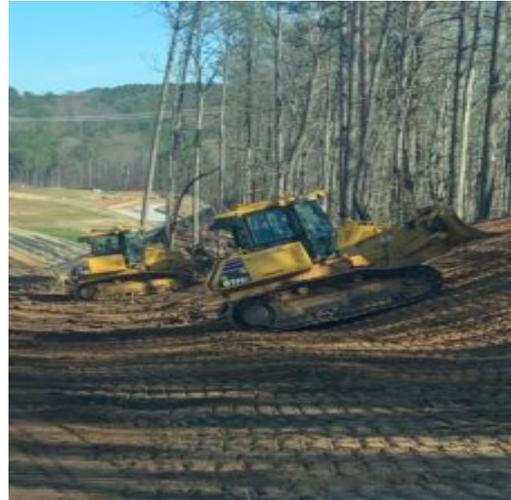
Slope grading and stabilization at Nature Walk parkway
