Date : 12/30/2025
Project No : 2025C260
Client Company : Artisan
Arrival Time : 12/30/2025 09:30
Onsite Hours : 06:00

ASEC Report ID : 88910
Name of the Project : NW (PHASE 2) Parkway Extension
Project Location : Dallas
Weather : sunny
Departure Time : 12/30/2025 15:30
ASEC Technician Name : Clyde Smith

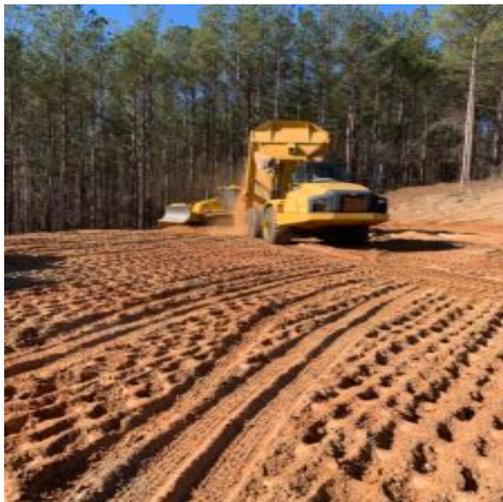
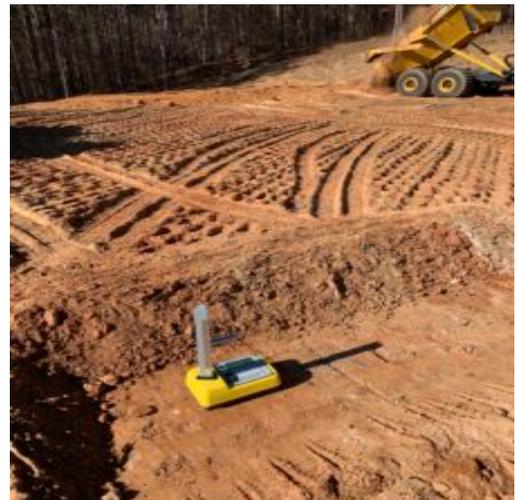
On the above date our representative was on site to observe the grading contractor continue to place fill for the cul de sac basement lots in compacted lifts. The writer performed density tests during fill placement using a Troxler Nuclear gauge model 3430, serial no. 91643. Compaction results were in compliance with job specifications. The contractor also spread mulch chips for the north side toe of slope embankment.

Fill placement and density tests at basement lots

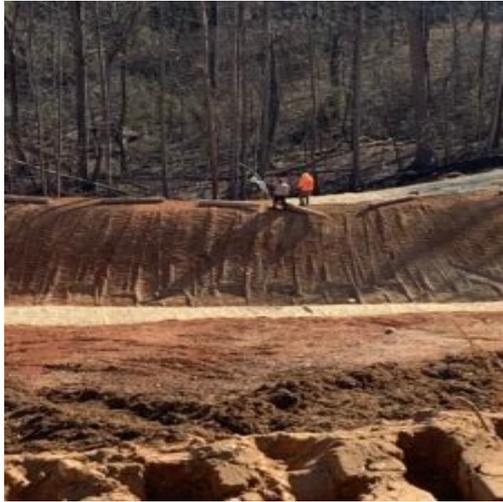
Grassing and mat blanketing
