Date : 02/12/2026  
Project No : 2025C260  
Client Company : Artisan  
Arrival Time : 02/12/2026 10:00  
Onsite Hours : 04:30

ASEC Report ID : 90392  
Name of the Project : NW (PHASE 2) Parkway Extension  
Project Location : Dallas  
Weather : Sunny  
Departure Time : 02/12/2026 14:30  
ASEC Technician Name : Sean Willett

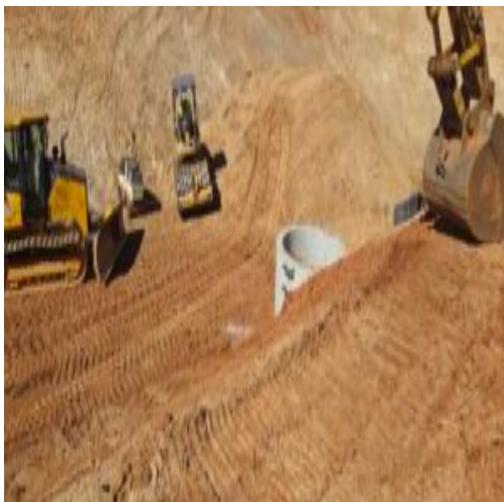
OCS/Pond

The pipe crew continued installation of the OCS in the pond below Lots #56 through #65. Backfill was placed and compacted around the structure. Density testing was performed and test results were provided to the contractor. The pipe crew continued to excavate rock along the main pipeline going up the hill to the entrance of the site (approx. SSMH-13 to SSMH-14 area). It appeared that they were able to excavate the rock from the trench without using the jack hammer at this time. The contractors stated they would not be backfilling this pipeline today. It was recommended to remove any large rocks greater than 2 feet in diameter, and to use a finer structural fill material mixed in with the smaller rock when they begin backfilling to fill voids.

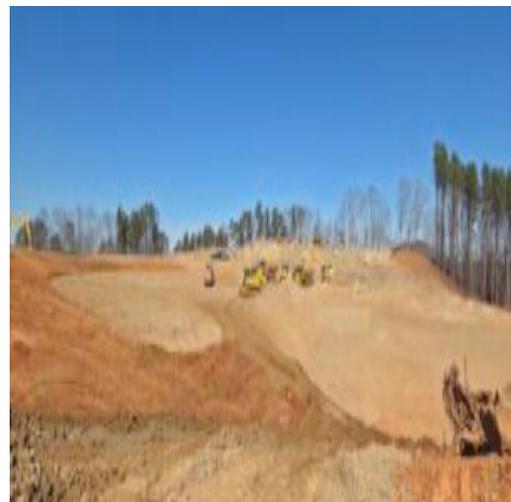
lots 56 -65

The grading crew is placing structural fill of approximately 8 to 12 inches in size across Lots #63 through #65. The soil lifts were compacted with a sheep-foot roller. ASEC watched as loaded off road trucks rolled across the lifts to check for stability. There was no severe pumping or deflection present at this time. Density testing was performed, and test results were provided to the contractor. Density testing was performed on the final grade of Lots #56 through #60. These test results showed poor compaction, and it was recommended to the contractor to recompact this area.
