Date : 12/10/2025  
Project No : 2025C269  
Client Company : Lewis Contracting  
Arrival Time : 12/10/2025 08:00  
Onsite Hours : 9:00

ASEC Report ID : 88605  
Name of the Project : Main St. & First Ave. - Mixed-use  
Project Location : Lilburn  
Weather : sunny  
Departure Time : 12/10/2025 17:00  
ASEC Technician Name : Samara Simha Reddy Kandi

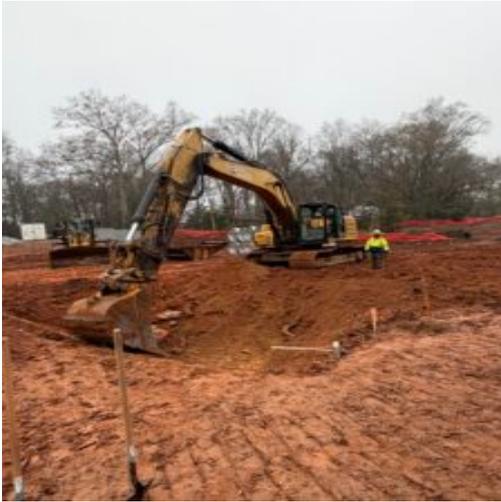
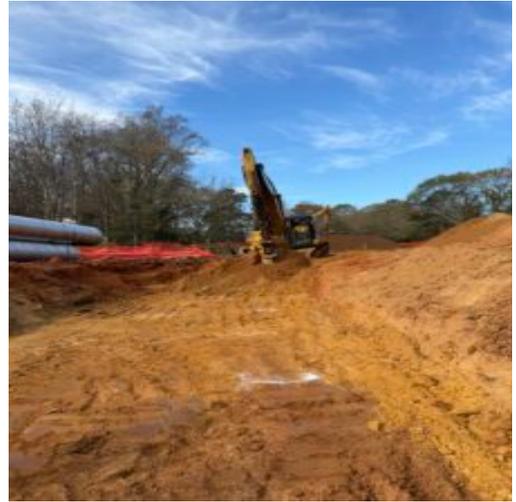
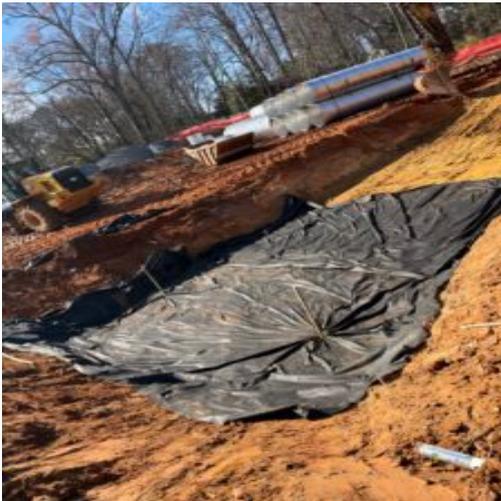
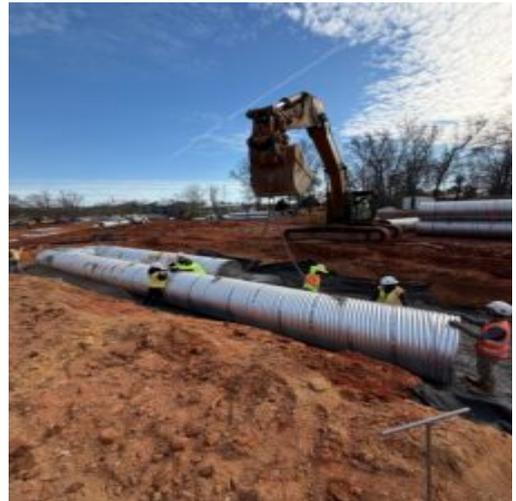
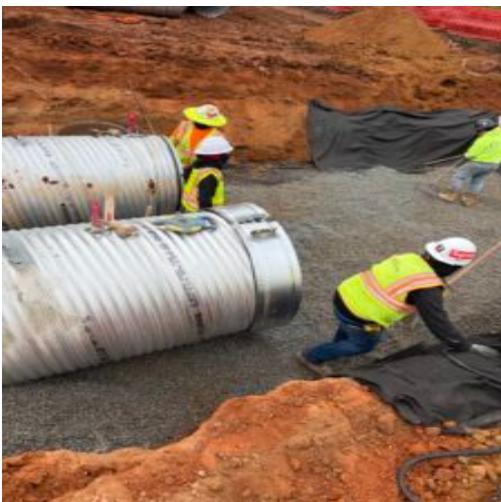
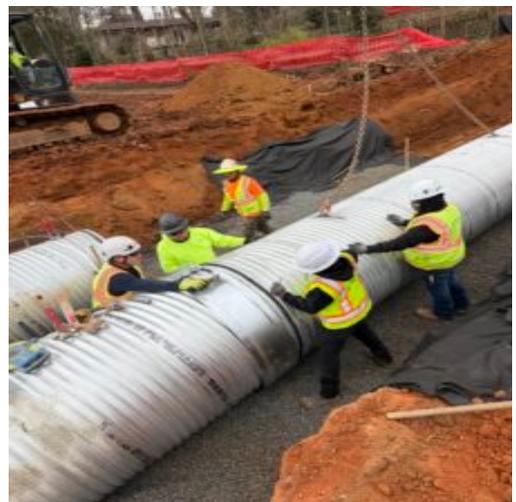
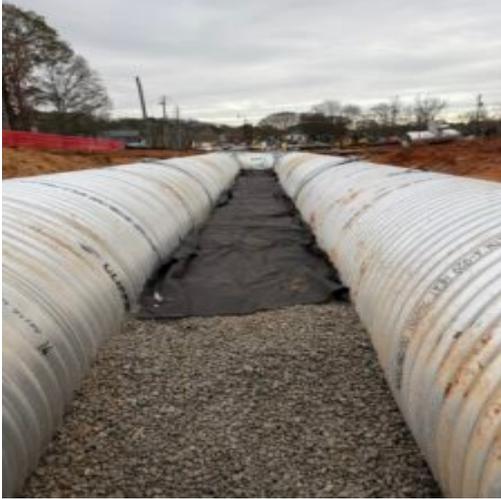
Work began at Pond 2 with the excavation of the stormwater detention trench. The crew excavated the area to an approximate depth of 6-7 feet and a length of 90 lineal feet, following the project design drawings. Excavation was carried out using a CAT hydraulic excavator, and the trench walls and base were shaped to the required lines and grades.

Following subgrade preparation, the crew installed a non-woven geotextile fabric across the entire trench footprint. This fabric serves as a separation and filtration layer, preventing fine soils from migrating into the stone bedding. After placing the fabric, a gravel bedding layer was placed and uniformly graded.

The crew then continued installing the Underground Stormwater Detention System (USDS). Large 36-inch diameter corrugated metal pipes (CMPs), each approximately 20 feet in length, were placed on the stone base.

Two parallel detention pipes were installed side-by-side, with an approximately 3-foot gap between them as required for stone coverage and structural spacing. The crew connected CMP sections to achieve a combined installed length of approximately 78 feet during today's work operations.

After pipe placement, the geotextile fabric was pulled up along the trench walls and partially wrapped around the pipes, helping to contain the gravel and prevent sediment infiltration.
