Date : 04/02/2026
Project No : 2025C269
Client Company : Lewis Contracting
Arrival Time : 04/02/2026 07:00
Onsite Hours : 01:00

ASEC Report ID : 92323
Name of the Project : Main St. & First Ave. - Mixed-use
Project Location : Lilburn
Weather : Sunny
Departure Time : 04/02/2026 08:00
ASEC Technician Name : Sean Willett

Our ASEC representative was on site to observe the contractor (Lewis Contracting) and for the observation/testing of the placement of fill/backfill.

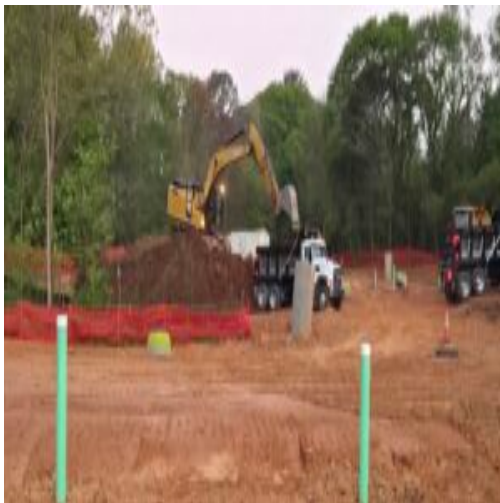
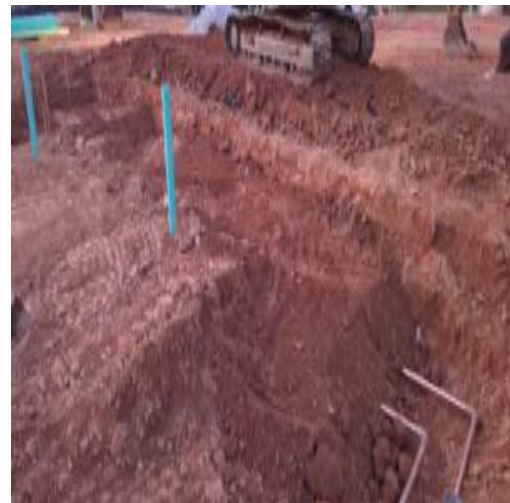
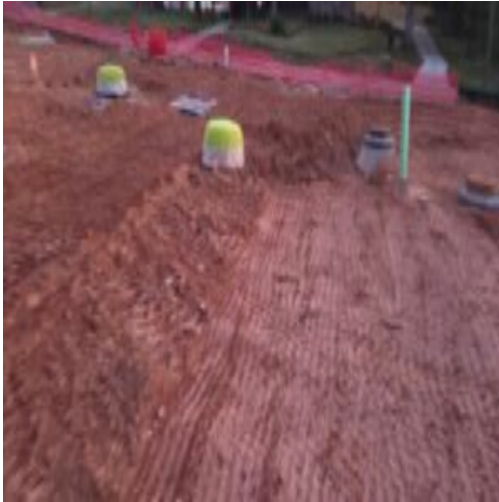
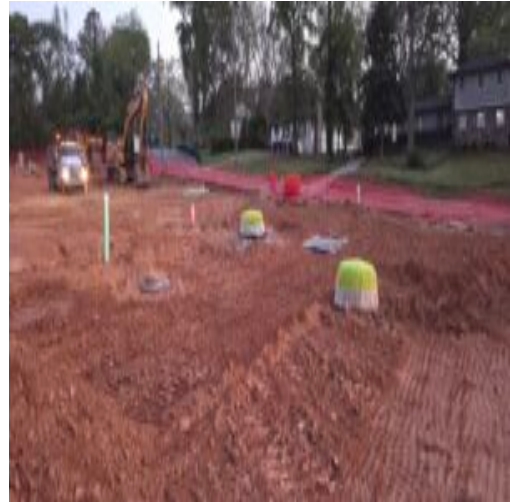
The contractor continued to place soil lifts approximately 12 inches in thickness across the water main that runs under main street into the site and around the grease traps. The lifts appeared to be compacted with a trench roller and a vibrating smooth drum roller. Density testing was performed, and test results were provided to the contractor. The contractor is starting to haul stockpiled topsoil off the site.
