Date : 04/21/2026
Project No : 2025C269
Client Company : Lewis Contracting
Arrival Time : 04/21/2026 13:30
Onsite Hours : 01:30

ASEC Report ID : 93306
Name of the Project : Main St. & First Ave. - Mixed-use
Project Location : Lilburn
Weather : sunny
Departure Time : 04/21/2026 15:00
ASEC Technician Name : Sean Willett

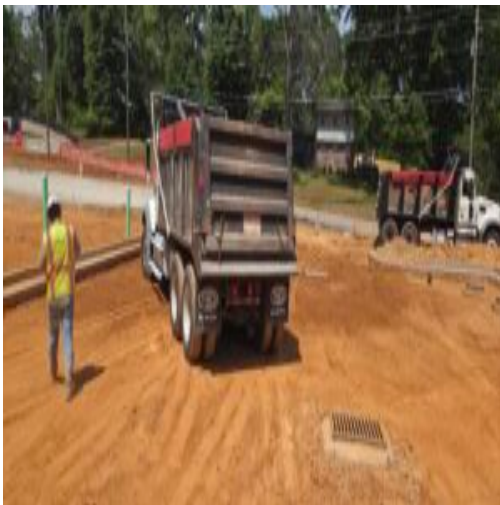
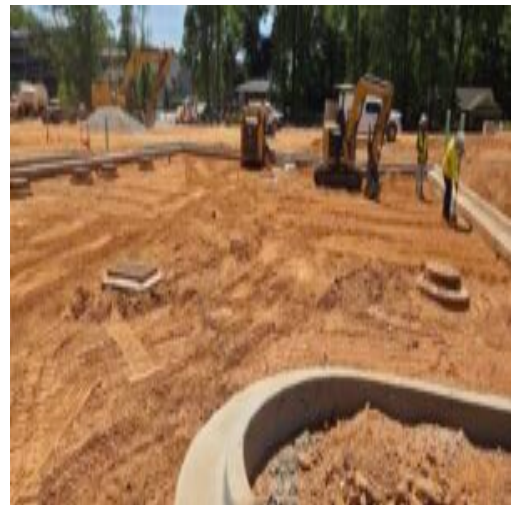
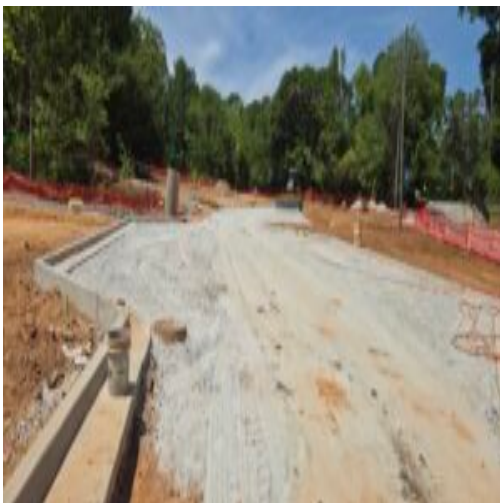
Our ASEC representative was on site to observe the contractor (Lewis Contracting) and for the observation/testing of the placement of fill/backfill. A proof-roll was performed on the grease trap area located in the middle of the site and the parking area for the town home lots. A loaded tandem-axled truck was used. There were no signs of severe pumping or deflection present in these areas. The contractors are still pouring curbs around the site. It appears the site is almost completed.
