Date : 01/09/2026  
Project No : 2025C281  
Client Company : SR Homes  
Arrival Time : 01/09/2026 07:00  
Onsite Hours : 02:00

ASEC Report ID : 89112  
Name of the Project : Owen Mills - Owens Store Rd  
Project Location : Canton  
Weather : Overcast  
Departure Time : 01/09/2026 09:00  
ASEC Technician Name : Sean Willett

## FIELD OBSERVATIONS

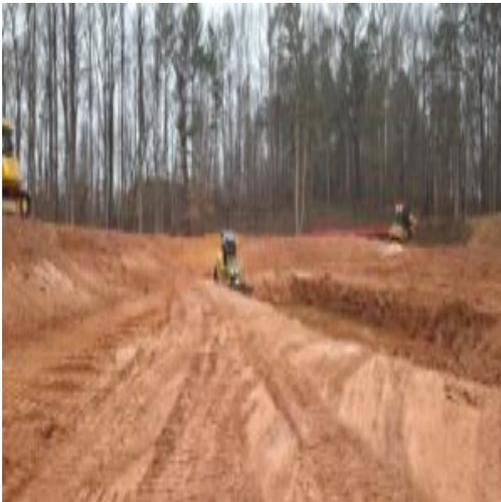
The contractor was completing the **final approximately 2 feet of fill placement** along the **dam embankment located at the rear of the site**. Fill was placed in **approximately 12-inch lifts** and compacted using a **sheepsfoot roller**.

Field **in-place density testing** was conducted along the dam embankment. Fill performance was further evaluated by **observing loaded off-road haul trucks traversing the lift**, which served as proofrolling. **No pumping, cracking, or instability** was observed during these activities.
