Date : 01/28/2026
Project No : 2026C103
Client Company : Artisan
Arrival Time : 01/28/2026 09:30
Onsite Hours : 08:00

ASEC Report ID : 89606
Name of the Project : NW PH 2, UNIT 4
Project Location : Dallas
Weather : cloudy
Departure Time : 01/28/2026 17:30
ASEC Technician Name : Clyde Smith

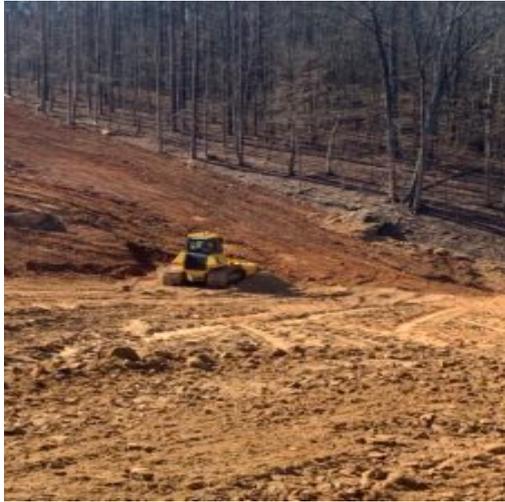
Our representative was on site to observe the grading contractor continue placing fill for building Lots #57 thru #59 at basement elevations -11 feet. The contractor also placed fill for building Lots #35 and #34 at elevation 883 (-13 feet). The fill was placed in compacted lifts that met job requirements. Density testing will be performed later today with results in a future report.

Fill placement at lots 57 thru 59

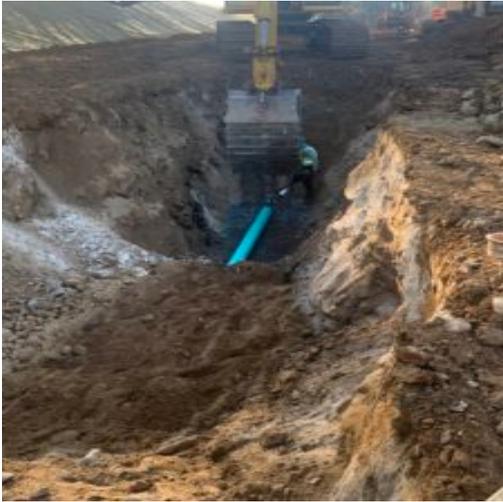
The writer also observed the pipe contractor continue to install 24" RCP storm line to manhole structure D12. An 18" RCP storm line was also installed from structure D12 to D19 and backfilled. Density tests were performed on the backfill using a Troxler Nuclear gauge model 3430, serial no. 91643. Results will be presented in a future report. The contractor also continued installing 8" PVC sanitary sewer line between structure #12 and 13. The contractor installed thirty-two feet of 8" PVC pipe, pipe bedding and continued backfilling over the pipe using No. #57 stone.

Note: The pipe contractor hammered rock to install thirty-two feet of 8" PVC sanitary sewer pipe (1.25 hours of hammering rock today).

Installation of 8" pvc sanitary sewer line between structure # 12 and 13

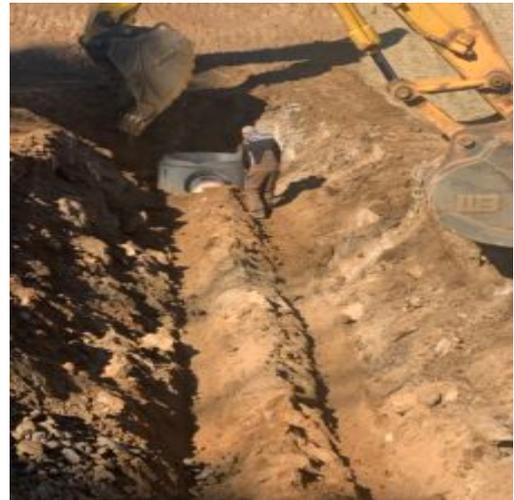
installation of 18" rcp storm between D12 and D19

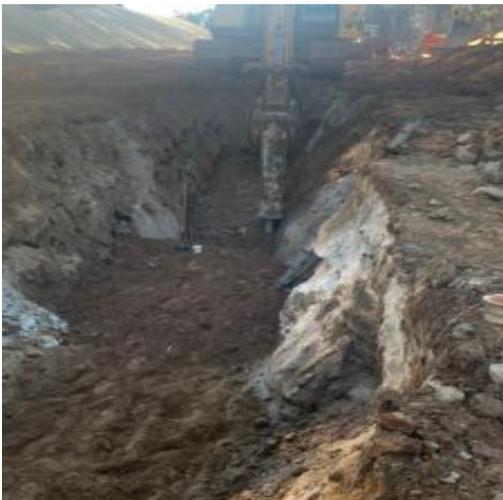
Also spoke with the blasting contractor (Clay with Advance) who was onsite yesterday (1/27/26) and received information from Thompson Grading and Savannah today that the Blast contractor performed test drill holes verifying un-blasted soft rock which was determined to be suitable to hammer and excavate using normal construction equipment. Note: Test drilled approximately 80 to 100 lineal feet. Rock was hammered for a 20' x 8' x 6' area between the sanitary sewer structures #12 and #13 with 3 hours spent hammering.

Hammering rock between structure # 12 and 13

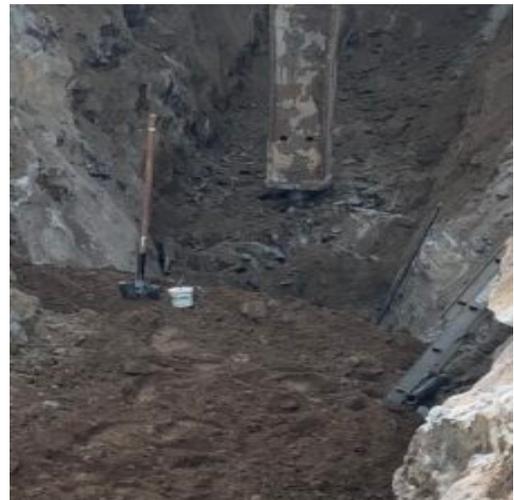
Hammering rock between structure # 12 and 13
