Date : 02/11/2026
Project No : 2026C103
Client Company : Artisan
Arrival Time : 02/11/2026 08:00
Onsite Hours : 07:00

ASEC Report ID : 90280
Name of the Project : NW PH 2, UNIT 4
Project Location : Dallas
Weather : Light rain
Departure Time : 02/11/2026 15:00
ASEC Technician Name : Clyde Smith

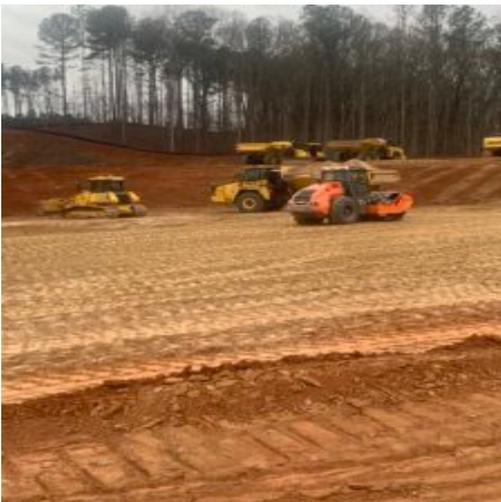
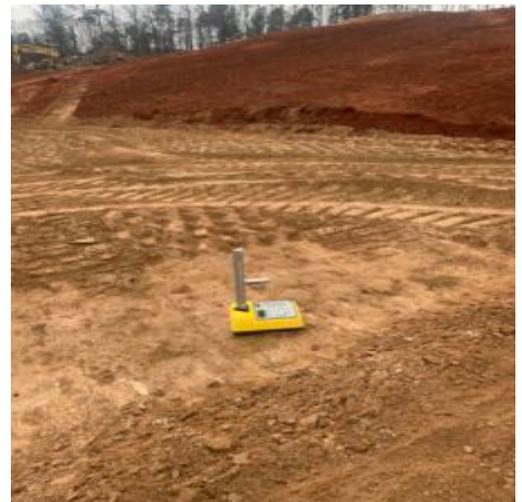
On the above date our representative was on site to observe the grading contractor continue placing fill for building Lots #63 thru 65. The writer performed density tests using a Troxler Nuclear gauge until light rain began. Compaction results were in compliance with job specifications.

Fill placement and density tests at Lots# 63 thru 65 .
