Date : 03/09/2026  
Project No : 2026C103  
Client Company : Artisan  
Arrival Time : 03/09/2026 08:00  
Onsite Hours : 9:00

ASEC Report ID : 91136  
Name of the Project : NW PH 2, UNIT 4  
Project Location : Dallas  
Weather : sunny  
Departure Time : 03/09/2026 17:00  
ASEC Technician Name : Clyde Smith

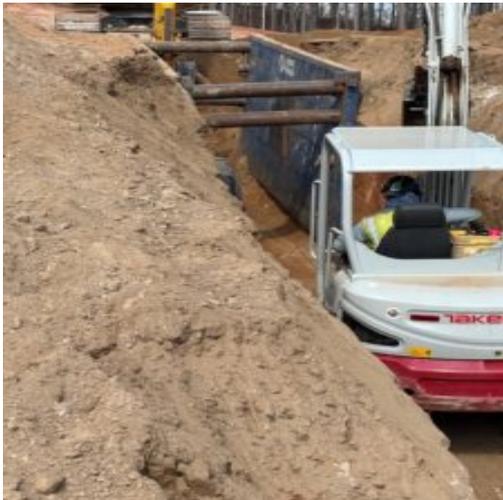
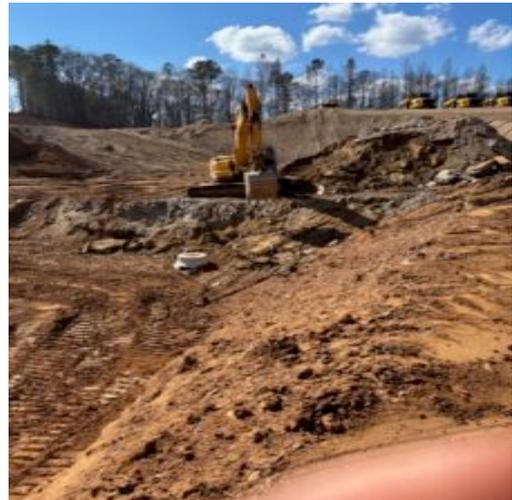
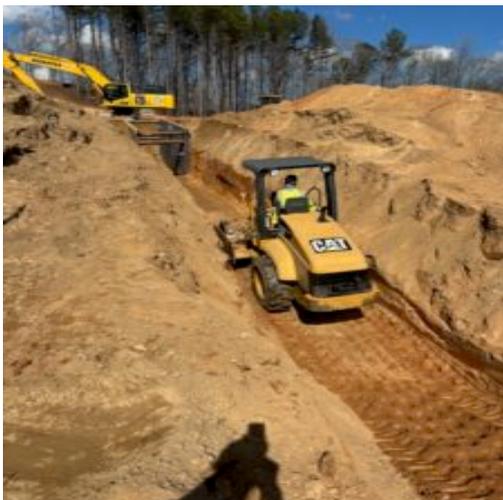
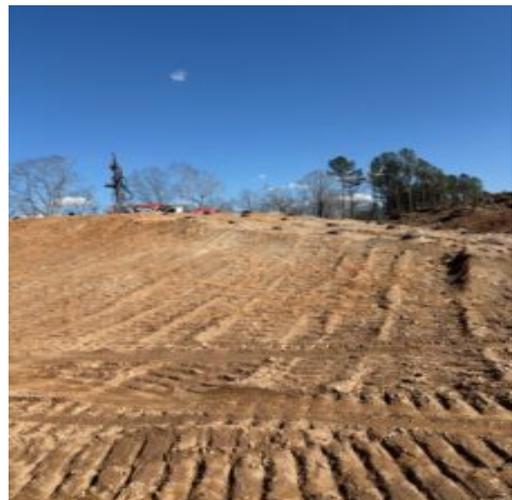
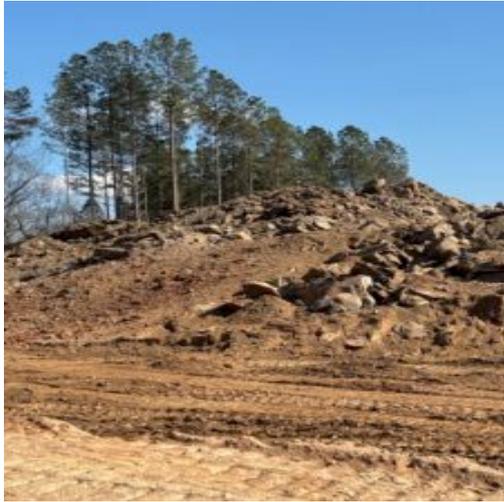
On the above date the writer was onsite as requested and observed the Pipe contractor continue installing 8" ductile iron sanitary sewer line between manhole structures #7 and 8. The writer observed backfilling at deep elevations which was placed and compacted in suitable lifts. The contractor had installed sanitary sewer line from halfway between manhole # 4 and 5, also from #5 thru 7 on 3/7/26 without the writer present onsite.

The Grading contractor continued placing rock fill at building lots# 33 thru 36 that was monitored by the writer at elevation 902. The observed rock fill placement was suitable for site specifications.

The Blast contractor (Advance) made a blast shot today at lots# 45 and 46. The blast drill log is attached.
